Beach Erosion and Sediment Processes Study, North East Marina, Erie County, Pennsylvania

Andrew Morang and Jeffrey Melton

June 2001

Final report

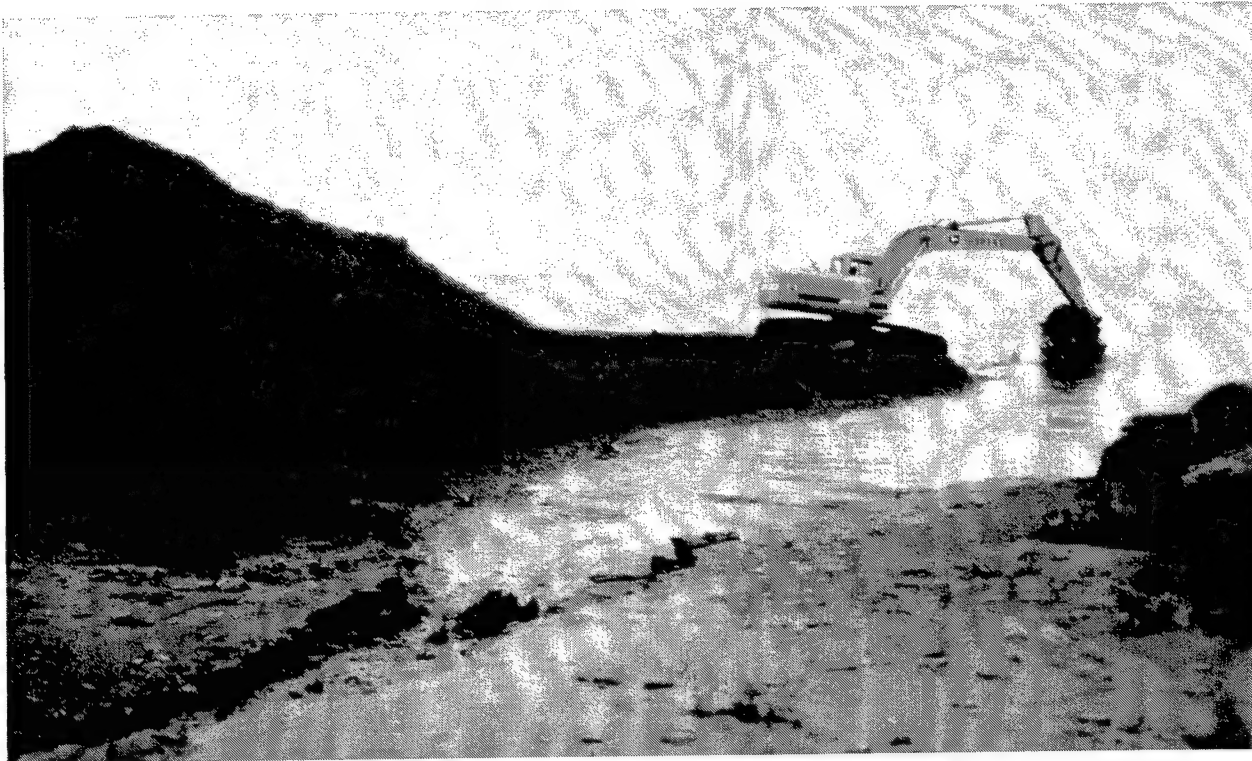
and gravel from the west side fillet into a 5-m-high pile. To obtain as much material as possible from the fillet, the backhoe operator builds a temporary road out into the lake (Figures 25 and 26). Dump trucks are loaded with sand and gravel on the west side, cross the marina, back up along the beach, and deposit their loads. The initial loads are used to build a road at the base of the bluff so that the trucks can proceed east away from the sheltering effects of the marina walls, up to a distance of about 500 m from the east wall (Figure 27). Then sand is spread on the beach and into the water, pushed about by bulldozer. Depending on waves, the road is sometimes partly washed away at night and has to be rebuilt in the morning. During the early 1990s, when lake levels were higher, the road had to be built into the lake to go around the barrels that protrude from one lakefront property.

Figure 26. Backhoe removing sand and gravel from updrift fillet, 17 November 1998. A temporary road allows backhoe to proceed out into lake over 30 m

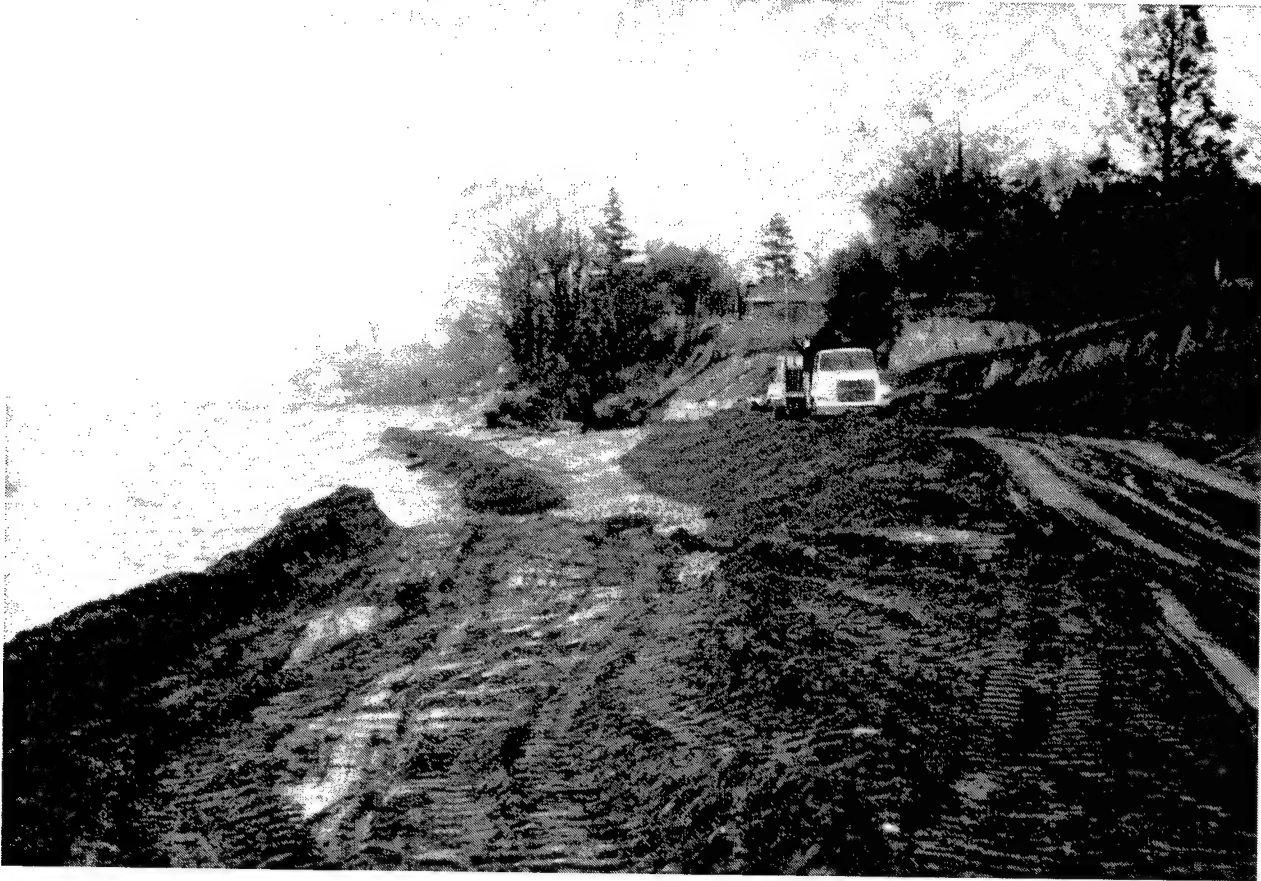
Figure 27. Temporary road along base of bluffs east of marina, 17 November 1998. Sediment is spread across beach and into water by a bulldozer

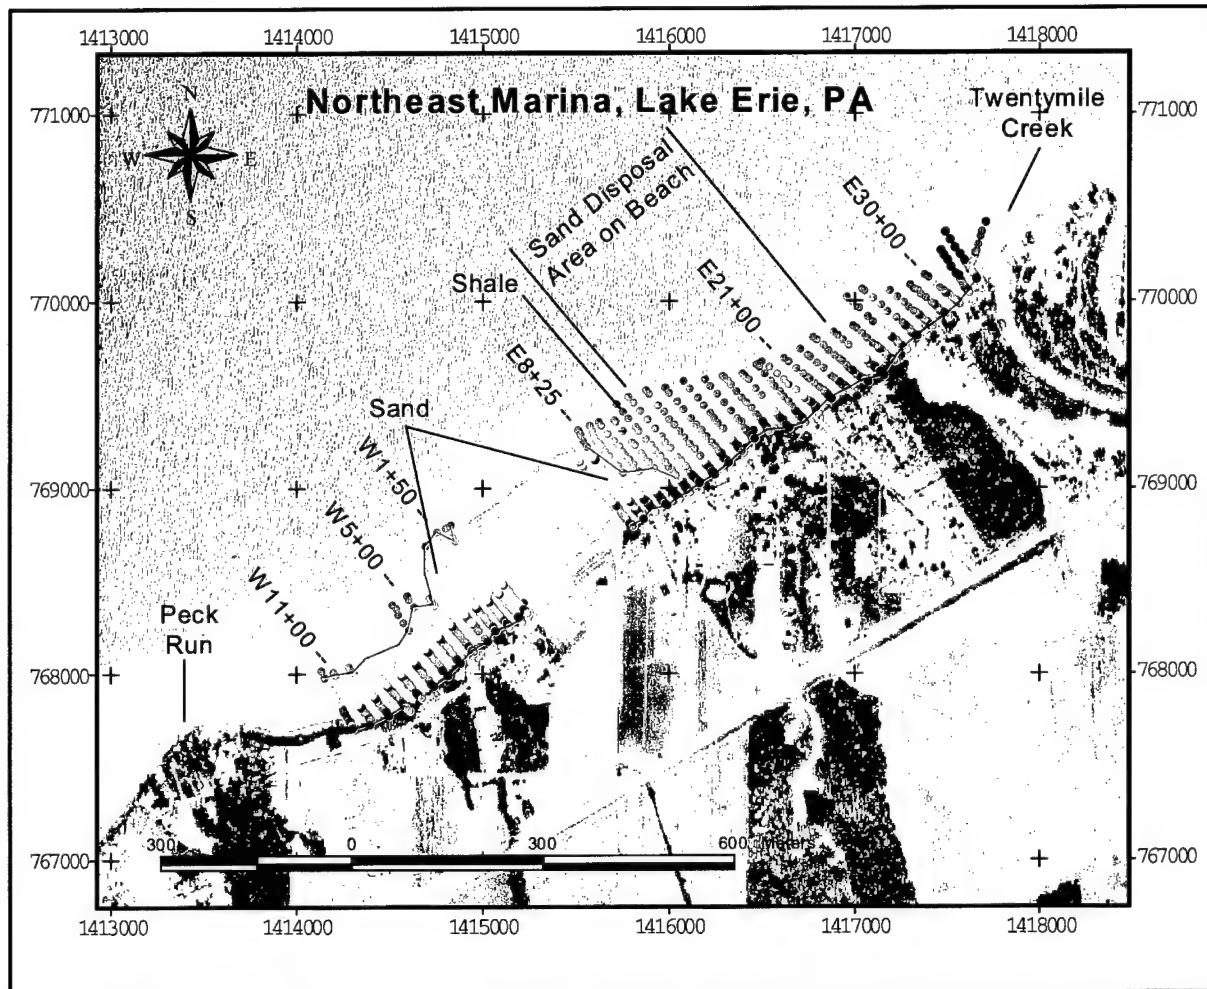
Figure 30. September 1999 profiles. State plane coordinate system, Pennsylvania North Zone, NAD 83, units in feet. Photograph is USGS digital ortho quarter quadrangle, converted from UTM coordinates to PA state plane (To convert feet to meters, multiply by 0.3048)

- c.* The volume of sand east of the marina has approximately doubled since 1992. This sand is found in a fillet that extends about 120 m east of the east wall (Figure 30). Part of this volume is in the upper beach, remnants of the temporary roadway placed by the PFBC.

- h.* Based on the analysis of profile volumes, line E1050 is the easternmost limit where the influence of the marina can be detected with respect to sediment accumulation (or loss) on the beach (Figure 30). This profile is about 120 m (400 ft) east of the east wall. East of E1050, the 1999 profile volume is essentially unchanged compared to 1991 and 1992. The quantity of sand on the beach in this area, east of E1050, is minimal, only about 4 yd³/ft.

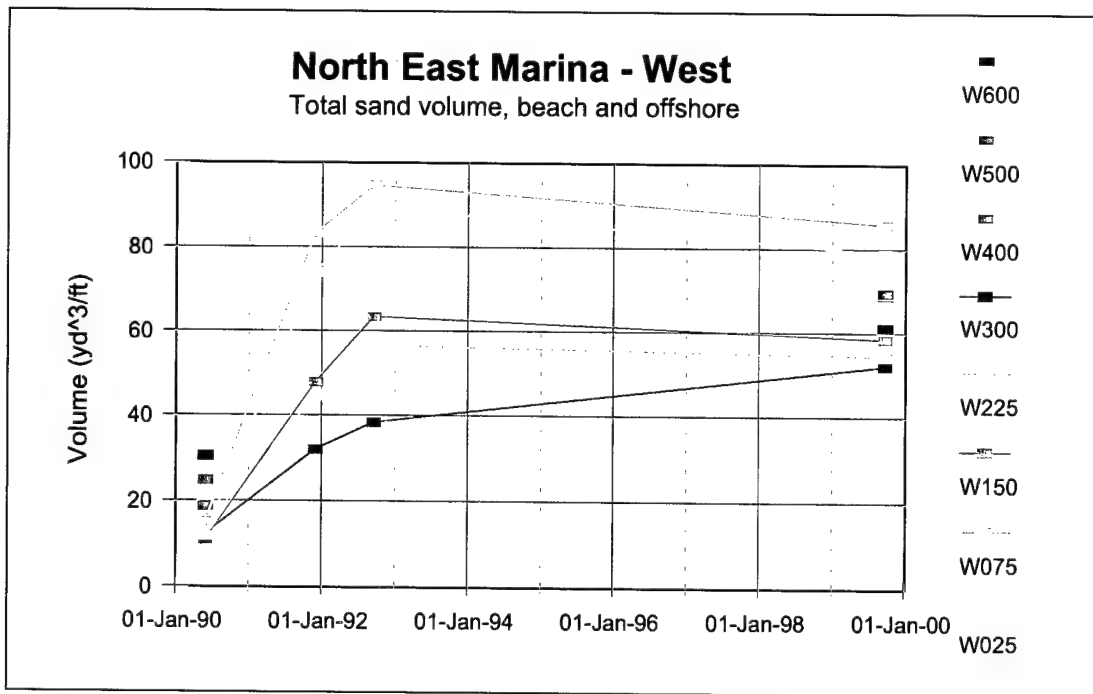
The results are easier to visualize as graphs. Figure 36 shows the volume changes over time for the west profiles. At all locations, volume increased rapidly between 5-30-90 and 9-16-92, during the period of marina construction, especially at lines W025 and W075. These data confirm the visual observations that a large fillet grew on the west side of the marina wall. The recent survey, 9-24-99, shows that the volumes of most of the west lines have stabilized or even slightly decreased. The period of stable overall volume coincides with the years that the PFBC has been bypassing sand from the west to the east side of the project. Only at line W300 did the volume increase from 1992 to 1999, and this is accounted for by the accumulation of sand on the upper part of the beach (see Appendix C). This is private property, west of the area where the PFBC mines the beach during its spring and fall bypassing operations.

Figure 36. Profile volume for lines W025 to W600 west of marina west wall. At W400, W500, and W600, data are only available for 1990 and 1999 and points have not been connected in this plot

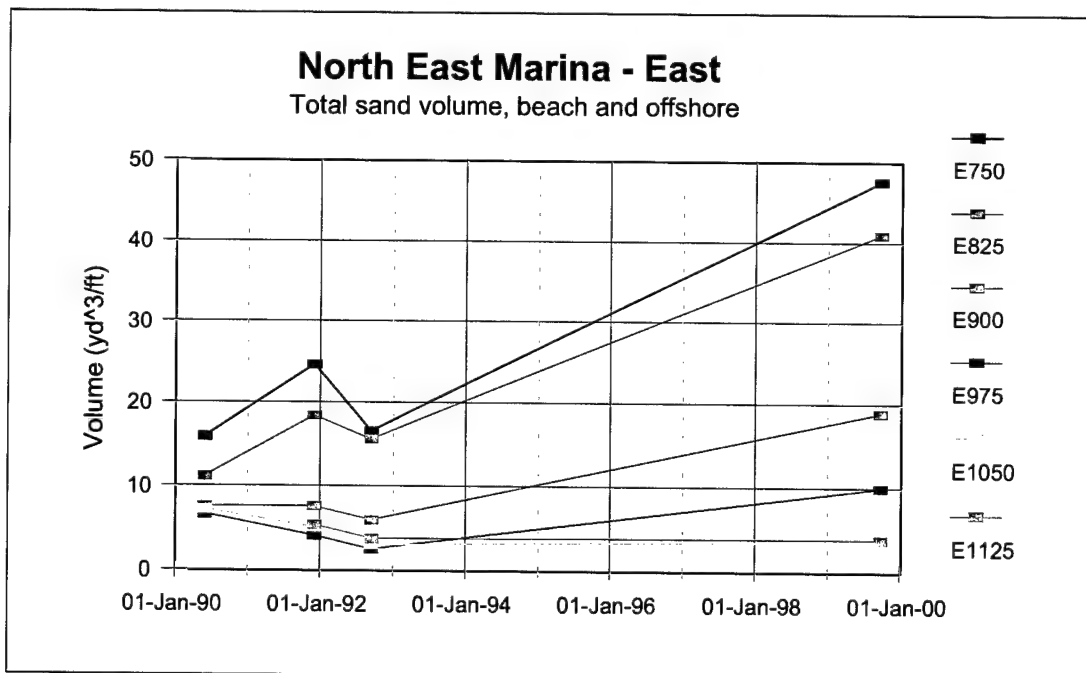
East of the marina, beach volume decreases towards the east (Figure 37). At the two lines closest to the east wall, E750 and E825, volume has more than doubled since 1992. Overall elevation has increased 0.3-0.6 m across the entire

beach, from the bluff toe to about 130 m offshore. Directly in front of the bluff, part of the 1998 fill remains as a raised terrace. Thanks to a mild winter storm season and dropping lake levels, the trucked fill was not completely removed as it had in previous winters. Profiles E900 and E975 also show volume increase, but to a lesser extent than the two lines closer to the marina. Profiles E1050 and E1125 were stable volume over time. These indicate that E1050 is about the easternmost limit where the influence of the marina can be detected with respect to sediment accumulation (or loss) on the beach.

Figure 37. Profile volumes east of marina. Most profiles show an increase in volume since 1992, but E1050 and E1125 are beyond influence of the structure

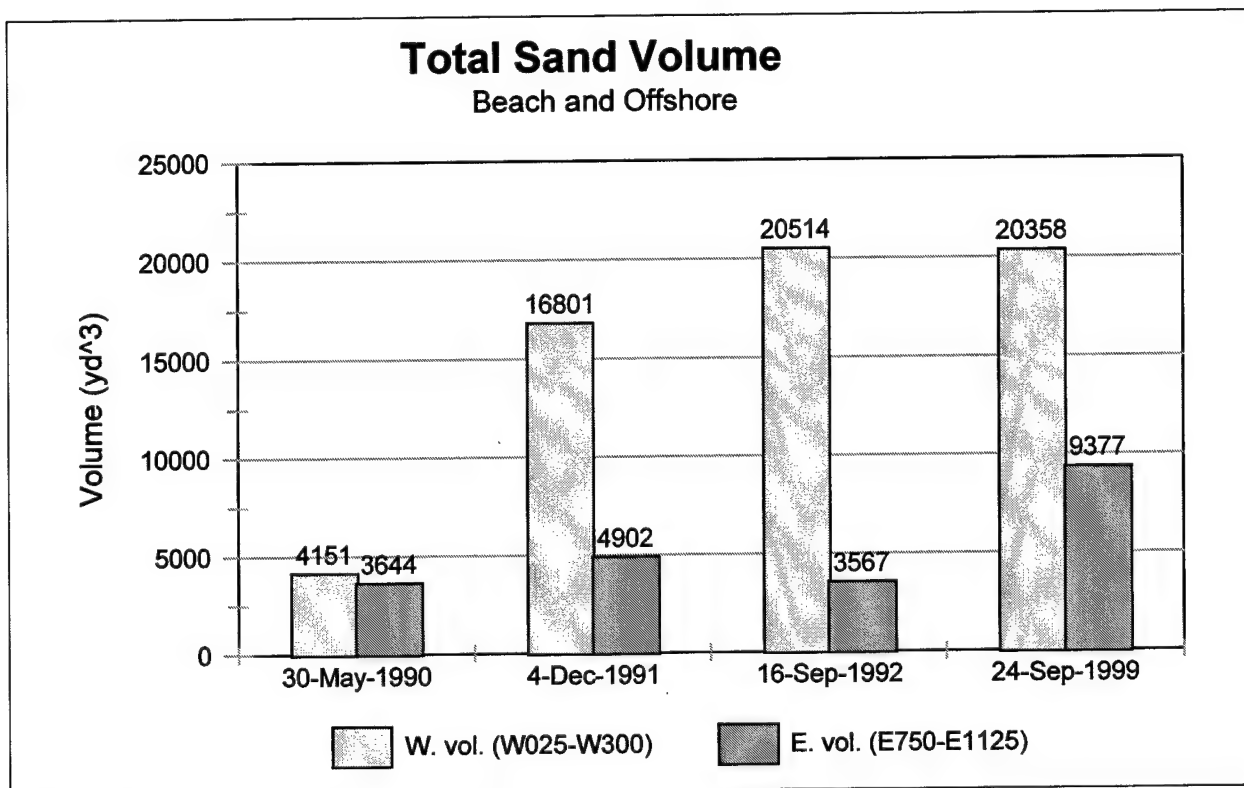
Figure 38 summarizes total volume change over time for the east and the west beaches. The west beach volume between W025 and W300 is almost identical to the 1992 volume, while the east beach has almost doubled. These data indicate that the PFBC has been bypassing a sufficient amount of sand to prevent a volumetric increase on the west side of the marina.

Figure 38. Total volume for west and east beaches. West of marina, volume has been stable since 1992, while to the east, total beach volume has almost doubled

Period 2: Spring 1994 to the present. Pennsylvania Fish & Boat Commission has effectively mitigated the disruption of eastward-directed littoral transport because the volume of sand bypassed during the biannual trucking operations has been approximately the same as the amount of sand brought into the fillet region by littoral processes. In September 1999, the total volume between profiles W025 and W300 remained unchanged at about 20,000 yd³, therefore indicating that the mechanical bypassing has been equal to the input supply (Figure 38).
